2000 60' Bertram Yachts Convertible Sport Fisherman
"Confidential"

Report of Marine Survey

Kevin Nicholson, Marine Surveyor, M.S., USPAP

October 9, 2021 at 7:15 A.M. EST (Limited trial run) & October 10, 2021 at 10:00 A.M. EST (In water)

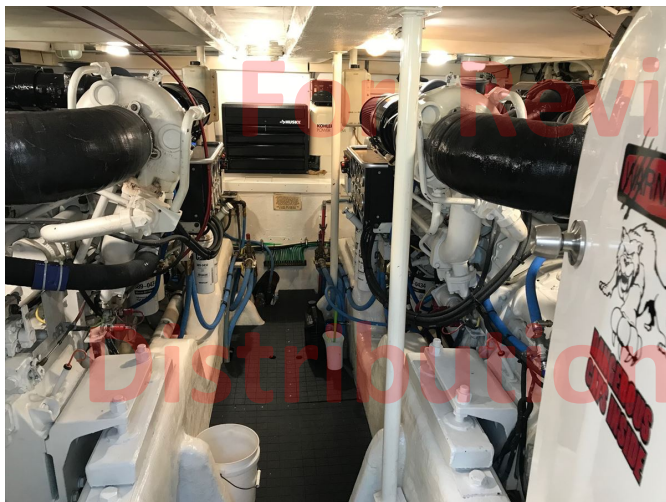
FINDING A-5 TOOL BOX

The tool box was unsecured on the engine room shelf between the generators and may likely be hazardous underway.

RECOMMENDATION

Properly secure the tool box and its drawers from opening.

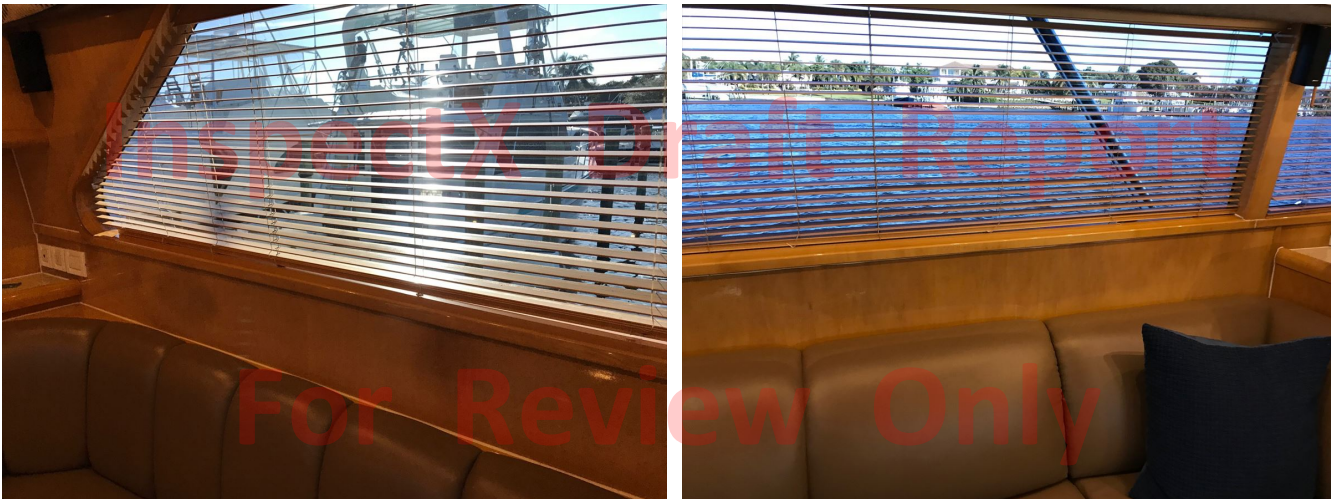
FINDING C-11 WALL-LINERS

Based on the Surveyor's physical inspection and information supplied by the listing Agent/Broker, the subject's port and starboard salon windows previously suffered from water intrusion resulting in discolored wood veneer below said windows. It was further indicated that the window leaks have been recently repaired by Glass Tech Marine in Miami, FL.

RECOMMENDATION

Monitor, refinish, or replace the wall-liner, as necessary.
