2000 60' Bertram Yachts Convertible Sport Fisherman
"Confidential"

Report of Marine Survey

Kevin Nicholson, Marine Surveyor, M.S., USPAP

October 9, 2021 at 7:15 A.M. EST (Limited trial run) & October 10, 2021 at 10:00 A.M. EST (In water)

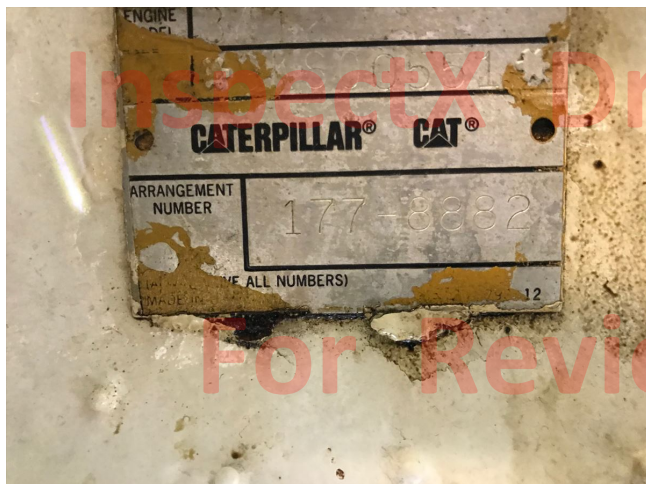
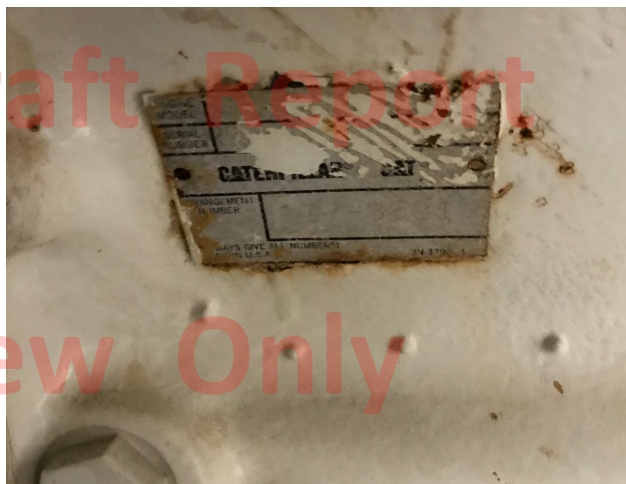
The engines have been painted and worn, and as a result portions of the engines' labels/tags were illegible.

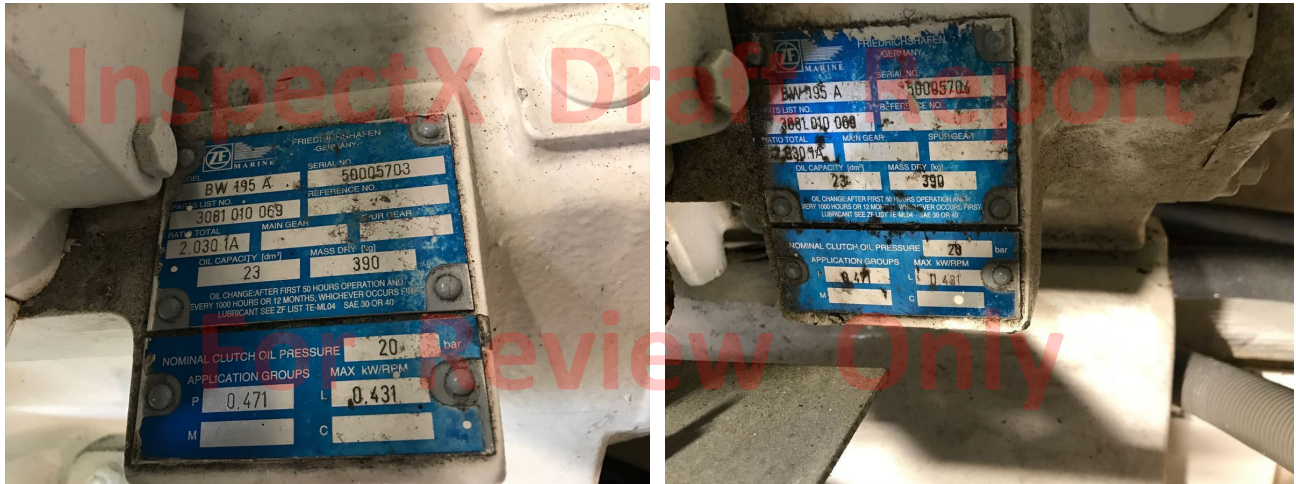
The subject was fitted with ZF Marine ClearCommand Electronic Controls. The drive systems were observed before, during, and after the limited trial run as having smooth shifting and no overheating, leaks, or vibrations were discovered. The transmissions were demonstrated, suitable for their intended use, and showed signs of usage requisite to the vessel's age, use, and being professionally maintained.

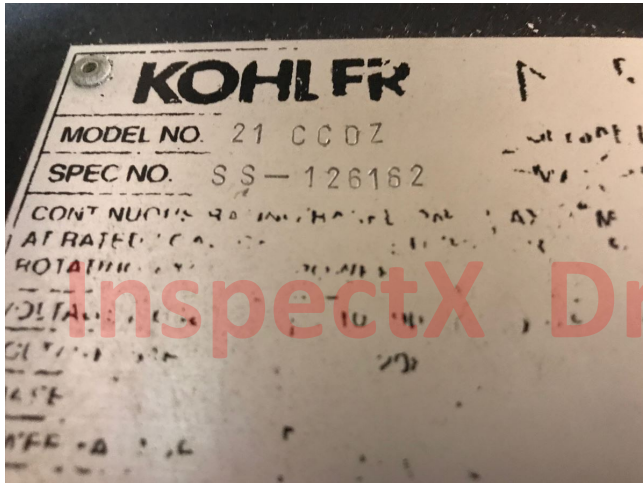
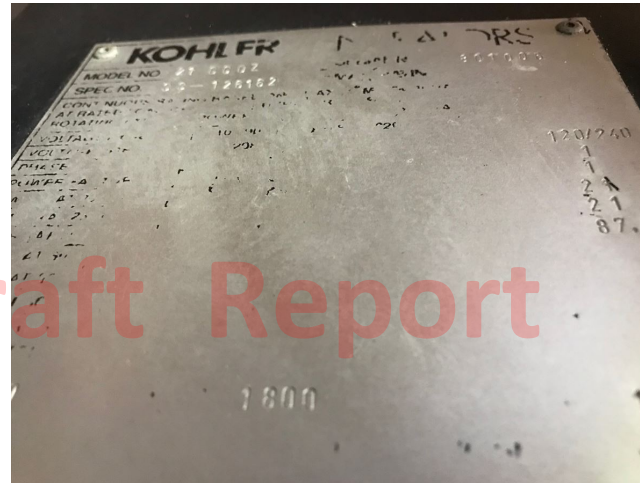
Appropriate tags and/or labels/notices were installed and are visible where sighted.
